Deliverable 4.3.2 PHC infrastructure accessibility assessment

Accessibility assessment to Ardino Hospital

Strengthening primary Medical care in IsoLated and deprived crossborder arEas

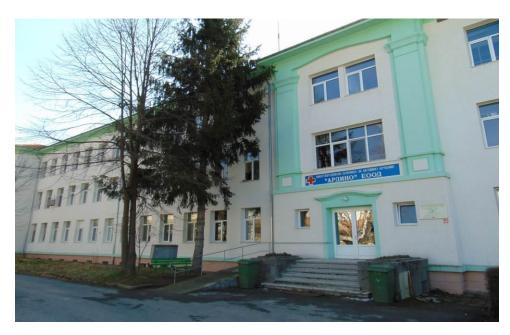
Photo: General view of the building

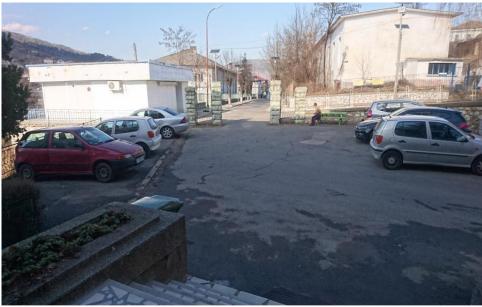
6 parking spaces for the use of the hospital's personnel and the general public are available at the hospital's yard. Spaces are not specifically marked.

Photo: Parking area in front of hospital's main entrance

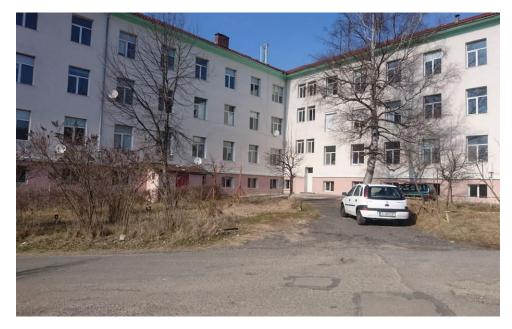
Also, parking of vehicles is possible in other parts of the yard, thus sometimes interrupting the work of the Emergency Aid Centre that is located in part of the building.

Photo: Parked vehicles in other parts of hospital's yard

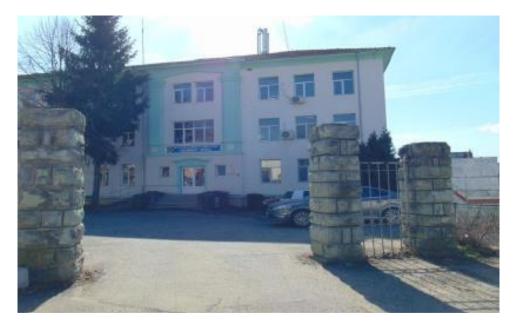
Access to the hospital's yard is achieved through a main entrance which remains open. A smaller door is available for pedestrians, although due to the vast opening next to it remains unused.

Photo: Entrance to the hospital's yard

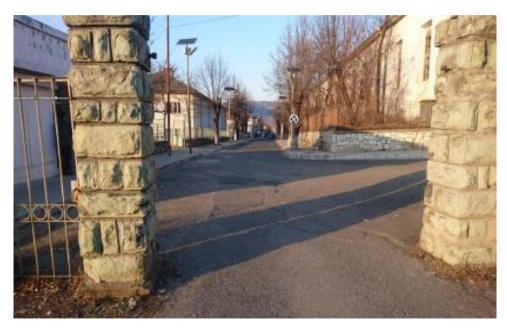
As the hospital is located at a L-shaped street, two sidewalks ensure the access to the building. Both sidewalks have pavement of concrete tiles, which is newly constructed and in very good condition. The pavement has sufficient width (an average of 2,20m) and has kerb of 0,20m with proper dropped kerbs constructed on both sidewalks.

Photo: The street and the L-shaped street in front of the hospital

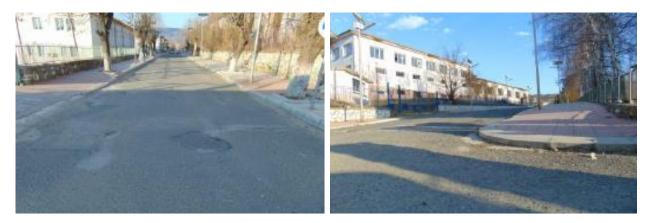
Photos: The street and sidewalk in front of the hospital

Unfortunately, the road in front of the hospital is in poor condition and appears to have maintenance problems which create an uneven and not homogenous surface, which may cause trouble when crossing the road and when reaching hospital's yard as the sidewalks finish before it. Actually, no sidewalks are constructed in the yard as the movement of pedestrians is done on the road, where cars and ambulances access the hospital. Sidewalks are available only at the backside of the hospital and are rarely used.

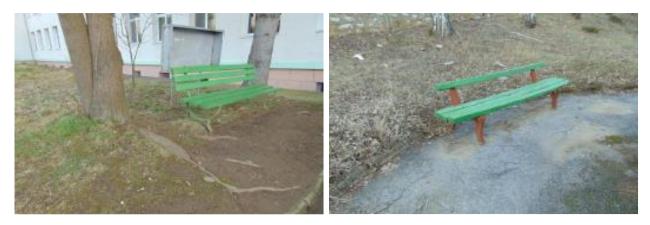
Benches are installed near the building's main entrance for the use of the building's visitors. The seat is located at 0,46m high. No handrails are available to assist users with reduced mobility. Their location and shape may also hinder the movement of visitors with visual disabilities, particularly those using white canes for their orientation.

Photos: Benches installed near the building's main entrance

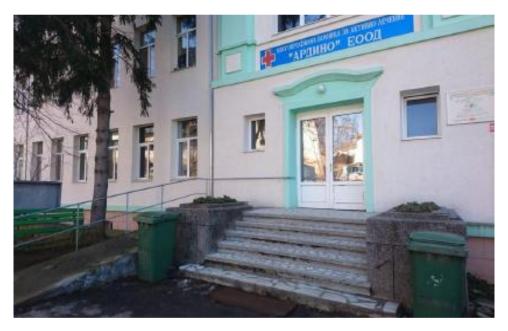
The main entrance has height difference of 0,85m with the level of the yard. Respectively, the access to the building is ensured by a straight staircase of 6 concrete steps covered with mosaic, each with dimensions 2,86 x 0,15 x 0,30m On the left side there is a concrete L-turn ramp, situated on the left side of the staircase. Its length is respectively 6,00m and 1,10m, and the width is respectively 1,25m and 1,10m with an inclination of 12,0% which is much higher than the maximum allowed by the Bulgarian accessibility guidelines. There is a landing that provides space to change direction with dimensions 1,20m and 0,80m, which is enough for a wheel chair. Also, handrails are installed with upper level at 0,75m and extended to more than 0,30m after the end of the ramp which leads the patient to a clear level space (1,90m to 2,10m) in front of the entrance that provides enough space to accommodate a wheelchair maneuver. No tactile surface indicators are available.

Photo: Staircase and ramp at the general entrance of Ardino hospital

The surface of the ramp has certain defects that may cause difficulties for people with disabilities but at the same time it seems to offer sufficient slip resistance characteristics.

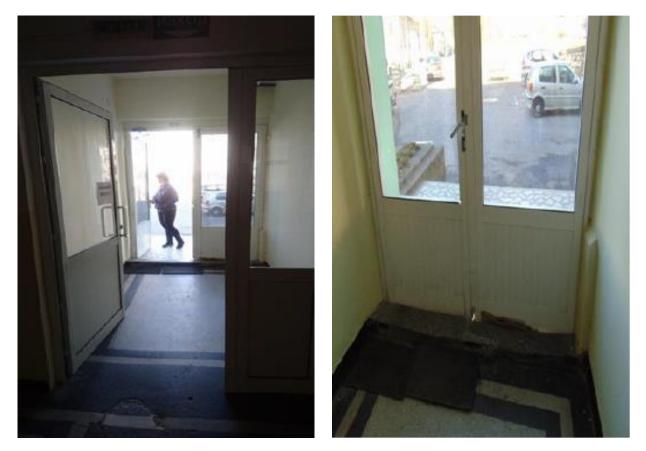
The main door has two opening leafs, with the total free width reaching 1,80m but the leaf that holds the handle is opening at 0,80m, which is the minimum that is required by the legislation and is valid only for specific cases. The door opens manually, to the outside of the building, through a handle located at 1,05m. Also, there is a 7cm threshold that can be non-negotiable for wheelchair users.

A vestibule is created after the main entrance with a width of 1,90m and a length of 2,50m. These dimensions are sufficient for ease of use. The vestibule leads to an internal door, with similar characteristics to the main one, with a clear length

1,50m and a main leaf opening at 0,95m, which is sufficient for wheelchair users. The second leaf stays fixed most of the time and is being opened whenever needed with the assistance of the personnel. The doors open manually in the same direction toward the outside of the building, through a handle that is located between 0,70m and 1,00m.

Photo: Doors of the main entrance and a vestibule

Photo: Threshold at the door of the general entrance

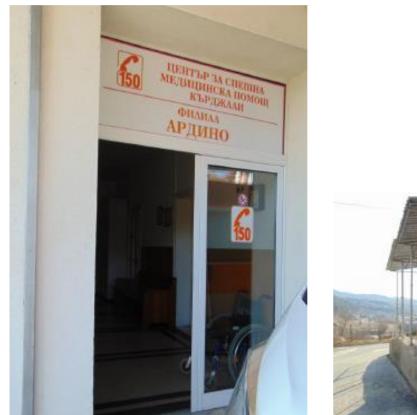
A double-sided concrete ramp leads to the entrance. The ramp's inclination is significant - about 22,5% with slight variations due to the construction but still it is impossible to be used by wheelchair users without help from the personnel. Each side of the ramp is 3,0-3,1m long and 3,1m wide, leading to the landing with dimensions 6,00m to 3,1m and having a high difference of 0,70m. The surface of the ramp and the landing has certain defects that may cause difficulties for people with disabilities but at the same time it seems to offer sufficient slip resistance characteristics.

The ramp leads to an opening door which has 2,00m clear width, provided by two opening leafs of 1,00m clear width each. The opening is to the inside of the building by a door handle located at 1,05m high.

Handrails are installed along the whole length of the ramp and have upper level at 0,75m.

Photo: The 2nd entrance leading to the Emergency Aid Center Kardjali – Ardino branch Photo: Ramp leading to the 2nd entrance

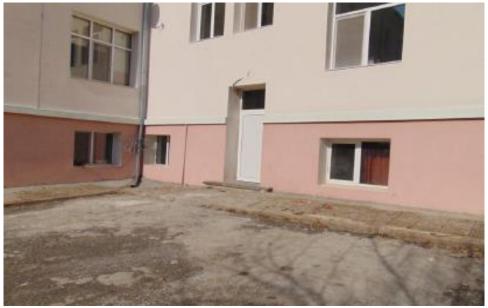
The third entrance, located on the back side of the building, is used only by the personnel. In this part of the yard, there is a sidewalk right next to the building with a kerb of 4 cm which is not dropped. Then, there is a small landing (1,00m to 0,48m) right in front of the door, which opens manually to the outside of the building, with a handle at 1,05m and a clear width of 0,80m. All this makes it not appropriate for wheelchair users.

Photo: The building's secondary entrance

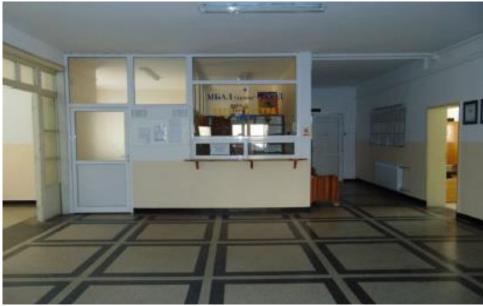
The information desk itself is located at 1,00m high, not allowing wheelchair users to have unobstructed eye contact with the centre's employee. The desk has a useful surface which can be used by the visitor in order to fill in forms etc. The dark brown colour against a light background creates sufficient colour contrast.

Photo: Info and registration desk at Ardino hospital

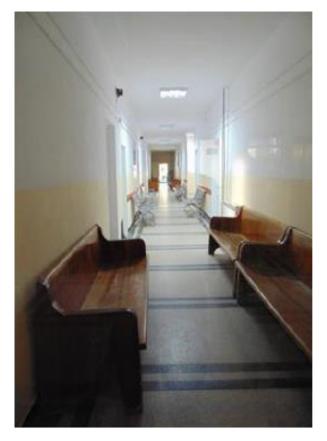
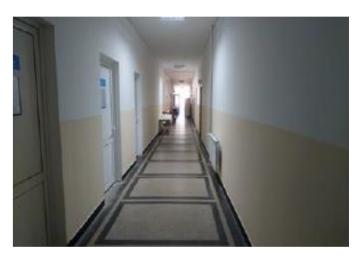
The vestibule leads to several corridors which connect the building's entrances with the Children's Ward, various examination rooms, the premises of the Emergency Help Centre Kurdjali – Ardino branch as well as to the main administrative rooms such as the Director's office and provides access to the other floors of the hospital through a staircase and elevator. Corridors' free width varies, with the minimum width being 2,20 cm and partly occupied by benches, located in the corridor with the examination offices. Still, there is enough space for wheelchair users including to make a u-turn.

Photos: Corridors in Ardino Hospital

The white color of doors and frames against a light background does not create sufficient color contrast in order to assist visitors with restricted vision.

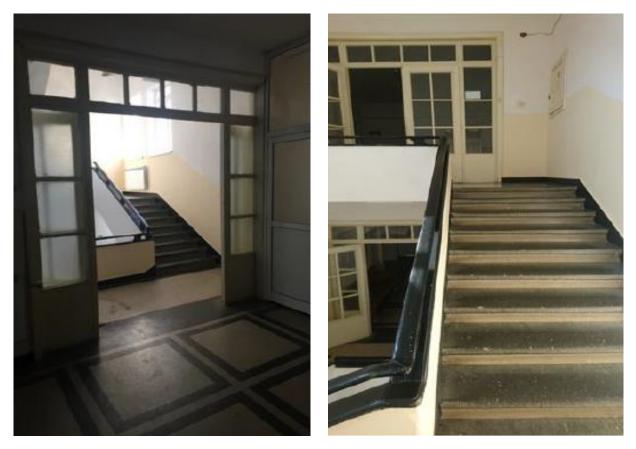
The main staircase consists of large stairs with turns and landings. The clear width slightly varies between 1,38m and 1,42m as the high of the riser is between 12,5 and 14cm. All stairs have depth of 30cm along the walking line.

The staircase is very light during the days as numbers of windows are installed. Superficial lighting by number of fluorescent lamps is provided for the rest of the time.

There are continuous handrails in the inner part of the staircase for protection and to help people.

Photos: Main staircase in Ardino Hospital

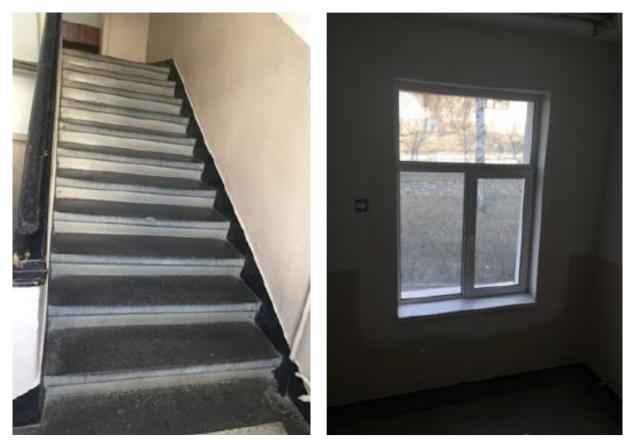
It consists of even stairs (width 1,25m, height 0,15m and depth 0,34m) with turns and landings. Natural lighting is provided by several windows but during the rest of the time the lighting is not enough.

There are continuous handrails in the inner part of the staircase for protection and to help people.

Photos: Secondary staircase in Ardino Hospital

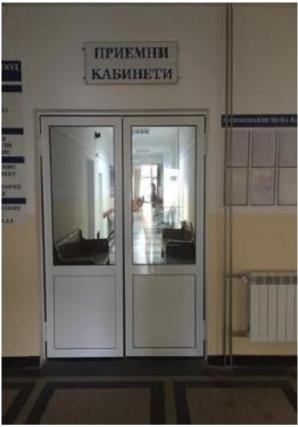
Examination rooms are located on the 1^{st} floor in the Eastern wing of the hospital. Rooms are located in a separate corridor, which begins from the large vestibule and are accessible through a door with two similar swinging leafs, each of which has free width of 0,70m and 1,40m in total.

Photo: Internal door leading to the examination rooms

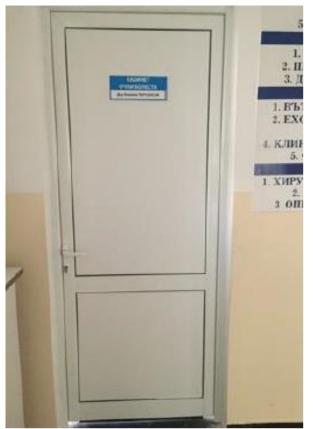
All the rooms have proper signage concerning the different uses of the rooms. The respective signs have antireflective surface and are located in the middle of the door at high of 1,60m, some signs – at 1,80m.

Photo: Signage on the examination rooms

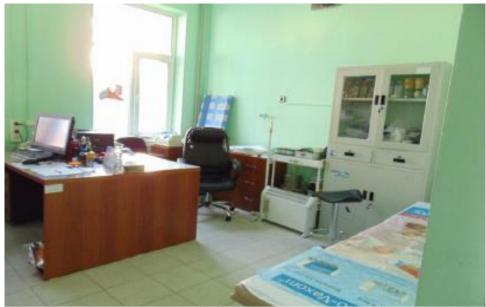
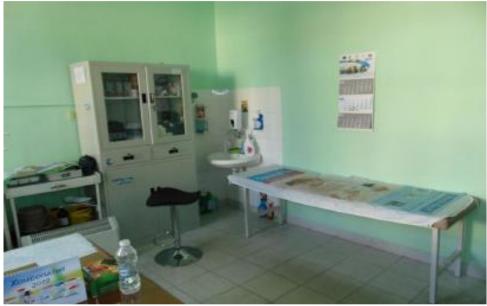
One of the examination rooms is the Pediatrician examination room. Its dimensions are sufficient (4,10m X 3,25m). The room provides enough space inside for a wheelchair user. There are two desks with dark color that provides enough contrast with the walls. In all other examination rooms there is only one desk and respectively even more space to enter and make a maneuver.

The various pieces of equipment (such as a baby scale) are placed at 0,80-0,90m high, the couch is at 0,90m high.

Photo: Pediatrician examination room

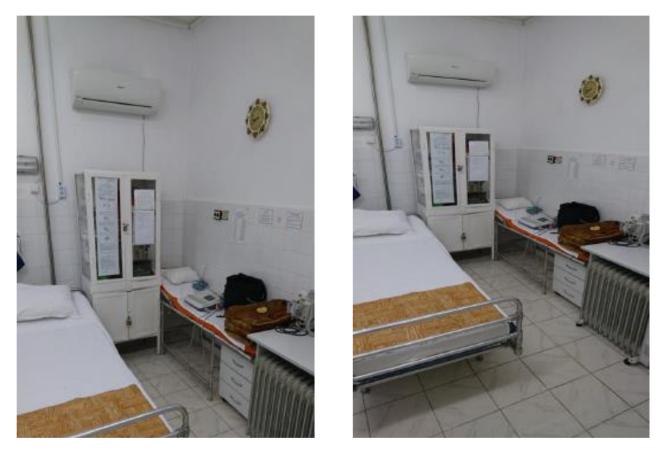
Currently, 4 premises are in operation, respectively Resuscitation and Manipulation, Dispatcher Cabinet, Doctor's Office and Driver's Room and after the completion of an on-going project of the Ministry of Health, 4 more premises will be equipped.

Photos: Emergency Aid Center Kardjali – Ardino branch

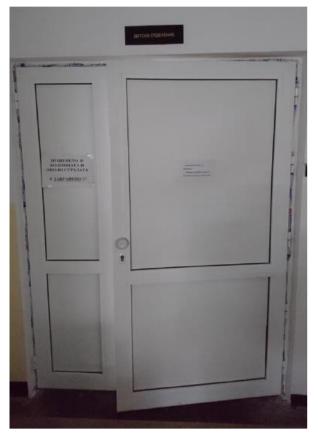
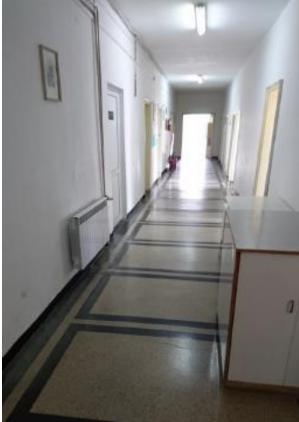
Children's Ward is located on the 1st floor in the Northern wing of the hospital. All premises are located in a separate corridor, which begins from the large vestibule and is accessible through a door with clear width 1,50m and a main leaf opening at 0,95m, which is sufficient for wheelchair users. The second leaf stays fixed most of the time and is being opened whenever needed. The doors open manually in the same direction toward the vestibule, through a handle that is located at 1,05m high. The corridor of the ward is 2,20m wide.

Photo: Doors leading to the Children's Photo: Corridor of the Children's Ward Ward

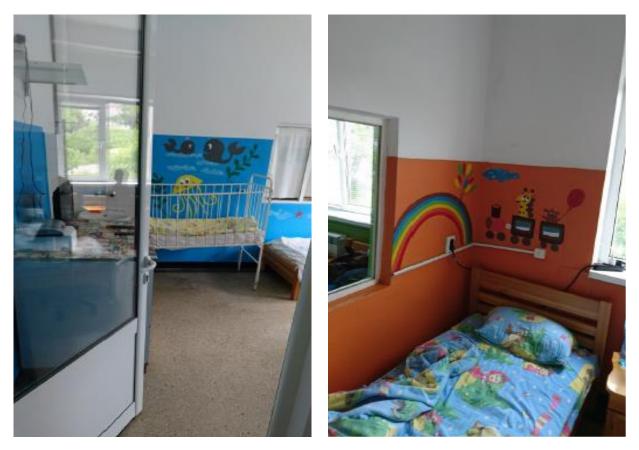
The Ward consists of the following premises: Cabinet of Head of Children's Ward, Ordinary Cabinet, Nurses' Room, Manipulation Room, Intense Care Cabinet, Warehouse, 4 hospital rooms (boxes allowing visual contact from the Manipulation Room), 2 isolators with separate bathrooms, 2 toilets (one for personnel and one for patients), bathroom, kitchen and dining room.

Photos: Patient's room in Children's Ward

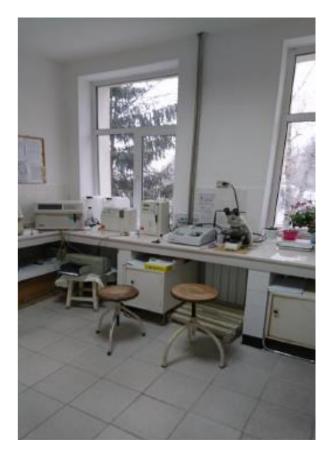
Clinical Laboratory and the respective related offices are located on the 2nd floor in the Eastern wing of the hospital. It is accessible through the main staircase and the elevator through the large vestibule. The corridor's that leads to the Laboratory has free width of 2,20m and is partly occupied by benches but they don't hinder the wheelchair users as well as provide enough space to make a u-turn.

Photos: Clinical Laboratory

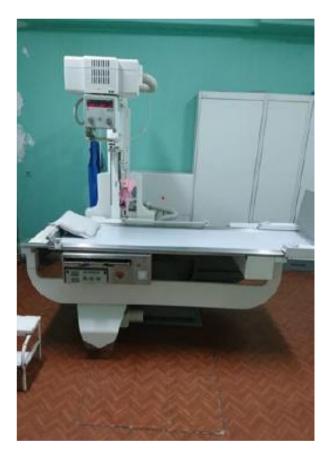
Photo: X-Rays Cabinet

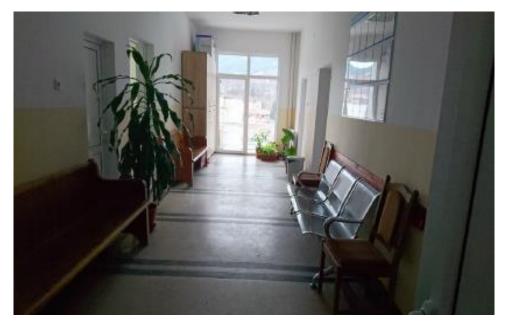
There are two ambulatories for primary outpatient care in Ardino Hospital, located on the 2^{nd} floor of the building. They are accessible through a door that leads to a small vestibule with benches. Each ambulatory has 4 premises,

Photo: Vestibule in front of an ambulatory for primary outpatient care

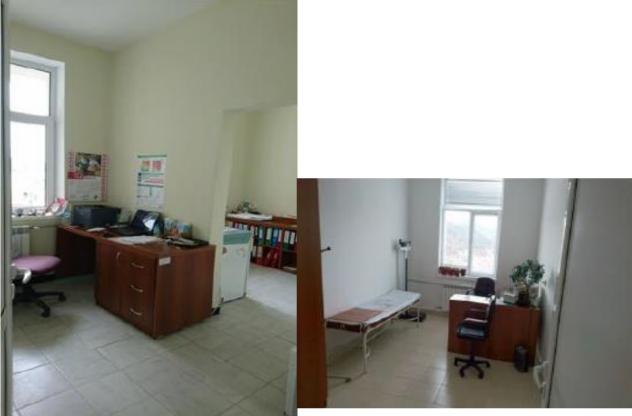
Photos: Premises of an ambulatory for primary outpatient care

The rooms have doors with dimensions $2,15m \ge 0,95m$ and free width of 0,90m, allowing easy access by wheelchair users.

Ordinary door handles are located at around 1,05 m. They are easy to operate without significant force to open and also can be operated with closed fist. Doors open inwards and provide easy access without a threshold or any other high differences.

Rooms are covered with terracotta and provide enough space for a wheelchair user including to make a U-turn. There are desks with dark color that provides enough contrast with the walls and various pieces of equipment that is placed at 0,80-0,90m high, the couch is at 0,90m high. They are not fixed and can be easily moved in case more space is needed.

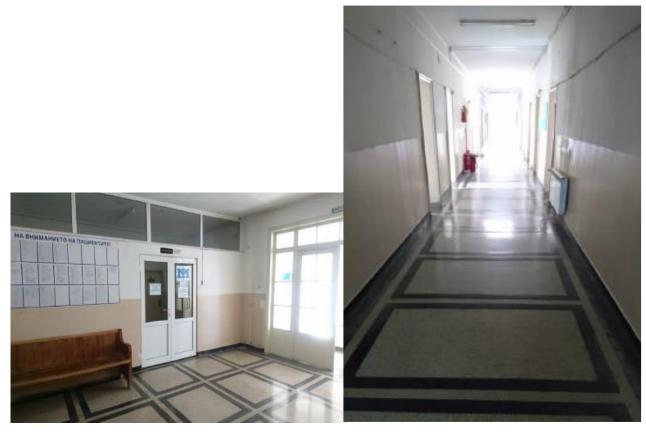
Surgical Ward is located on the 3rd floor in the Eastern wing of the hospital. All premises are located in a separate corridor, which begins from the large vestibule (similar to the one of the 1st floor) and is accessible through a door with clear width 1,80m and a main leaf opening at 0,90m, and a second leaf that is being opened whenever needed. The doors open manually in the same direction toward the vestibule, through a handle that is located at 1,05m high. The corridor of the ward is 2,20m wide.

Photo: Doors leading to the Surgical Ward

Photo: Corridor of the Surgical Ward

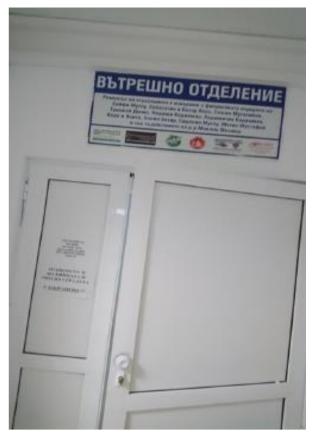
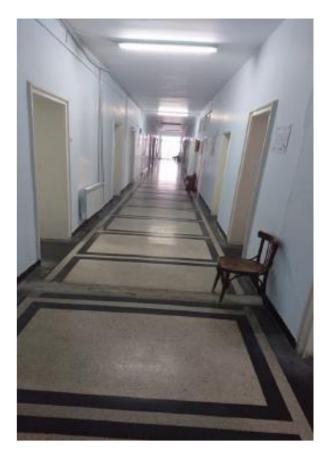
Internal Diseases Ward is located on the 2nd floor in the Northern wing of the hospital. All premises are located in a separate corridor, which begins from the large vestibule (similar to the one of the 1st floor) and is accessible through a door with clear width 1,50m and a main leaf opening at 0,95m, which is sufficient for wheelchair users. The second leaf stays fixed most of the time and is being opened whenever needed. The doors open manually in the same direction toward the vestibule, through a handle that is located at 1,05m high. The corridor of the ward is 2,20m wide.

Photos: Internal Diseases Ward

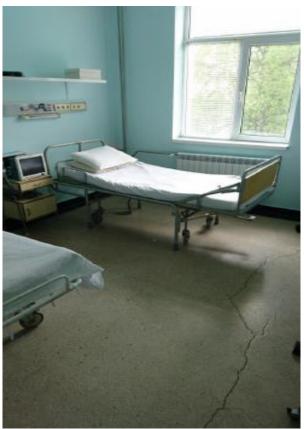
Photo: Patient's room in Internal Diseases Ward

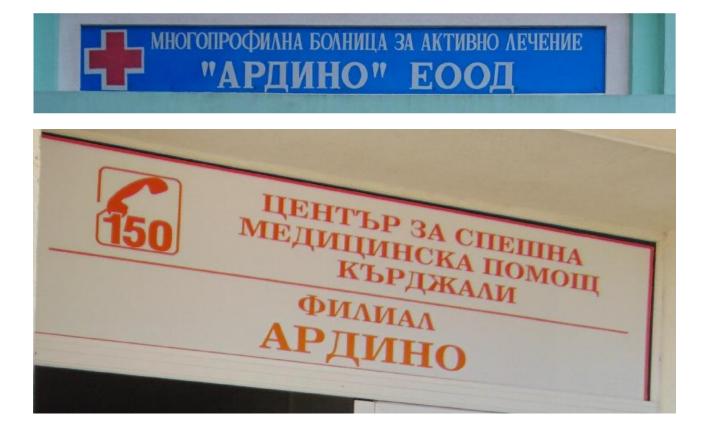
There are different types of signage used in the different parts of the hospital. In some cases, the signs are created by the personnel in order to provide visitors with useful information. Standardized template for the signs has been recently introduced with the renovation of some of the premises. No tactile signage is available and no colour coding is used in any form.

Photos: Signs at the hospital's exterior

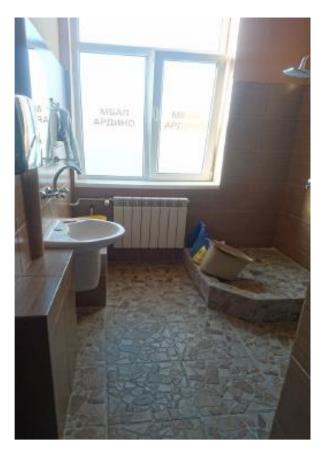
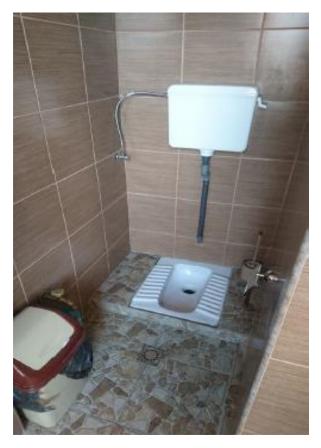
The hospital has 17 sanitary facilities (lavoratories/toilets) respectively 6 located on the 1^{st} floor, 5 on the 2^{nd} and 6 on the 3^{rd} . Some of them have been recently renovated (like the ones in the Children's Ward) and are in very good condition.

Photos: Bathroom in the Children's Ward

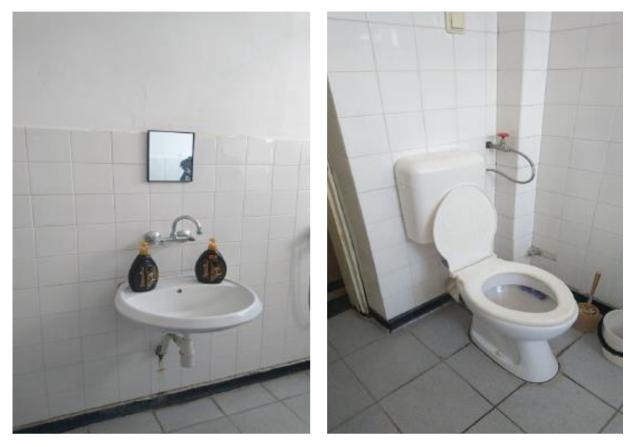
There is no specific accessible public restroom in the hospital. The one on the 1^{st} floor provides wheelchair users with enough space to enter and make a maneuver. Transition of wheelchair users is possible from the right side only and is not facilitate by a handrail. The top of the WC is located 40cm from the floor and has a flush tank button at 0,93m height.

There is easy access to the sink, which is in the same room, but its top is at 0,80m from the floor, with the tap located at 0,98m.

Photos: Restroom on the 1st floor
