Strengthening primary Medical care in IsoLated and deprived cross-border arEas

D.4.2.3

Pilot accessibility improvement study

| Description: | <p>The current document is the Deliverable D4.2.3 - Pilot accessibility improvement study</p> <p>It presents specific accessibility improvement suggestions for the PHC centre of Iasmos, based on the accessibility evaluation carried out at D4.2.2.</p> |

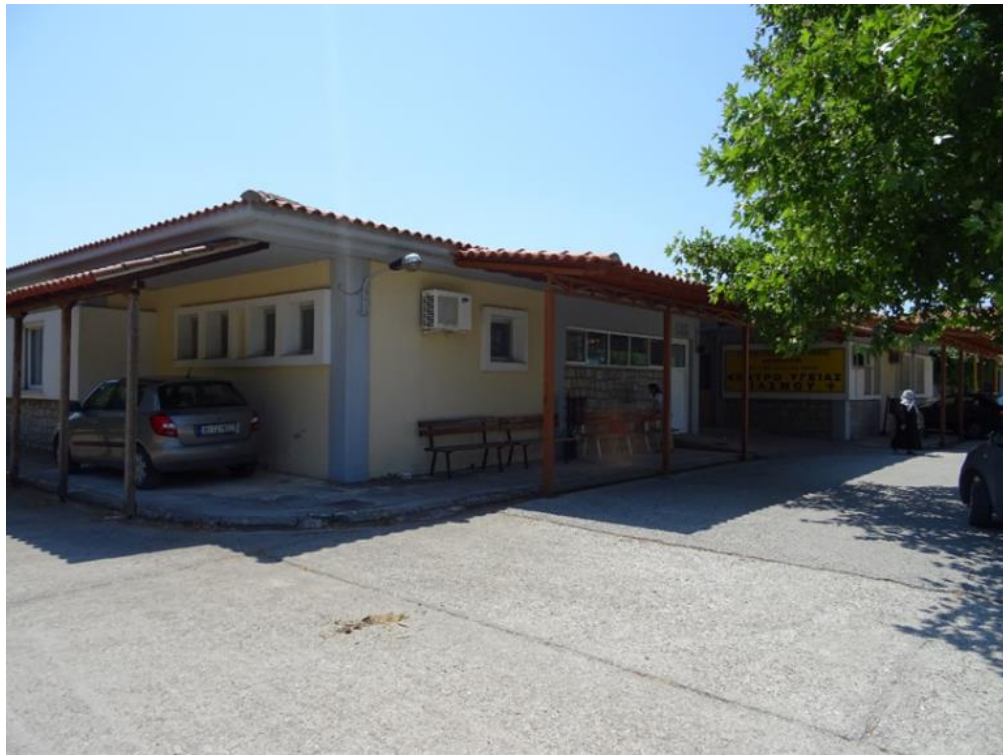
12 parking spaces for the use of the centre's personnel and the general public are available at the centre's yard. The spaces are covered and have dimensions $W = 6,3\text{m}$ and $L = 4,2\text{m}$. This allows at least two cars to park at each parking space. The shed covering the spaces leaves a free height of $2,25\text{m}$.

Figure 1: General view of the building

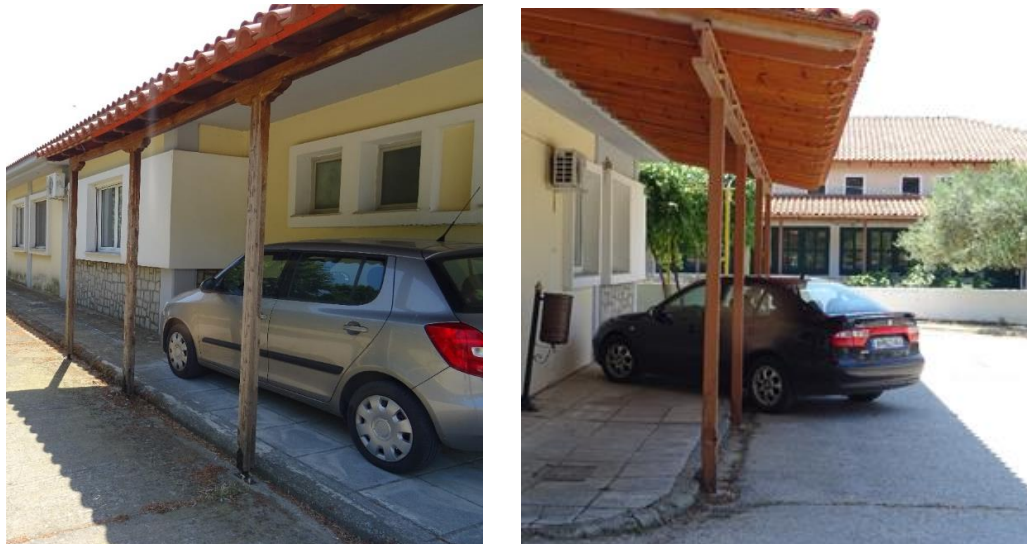
Furthermore, in some cases vehicles are parked at the pavement adjacent to the centre's building, thus interrupting the unobstructed movement of the building's visitors.

Figure 2: Vehicles parked on the building's pavement

Since no designated parking spaces are yet envisioned for disabled visitors, it is proposed that new ones, designed according to relevant Greek legislation and guidelines are constructed.

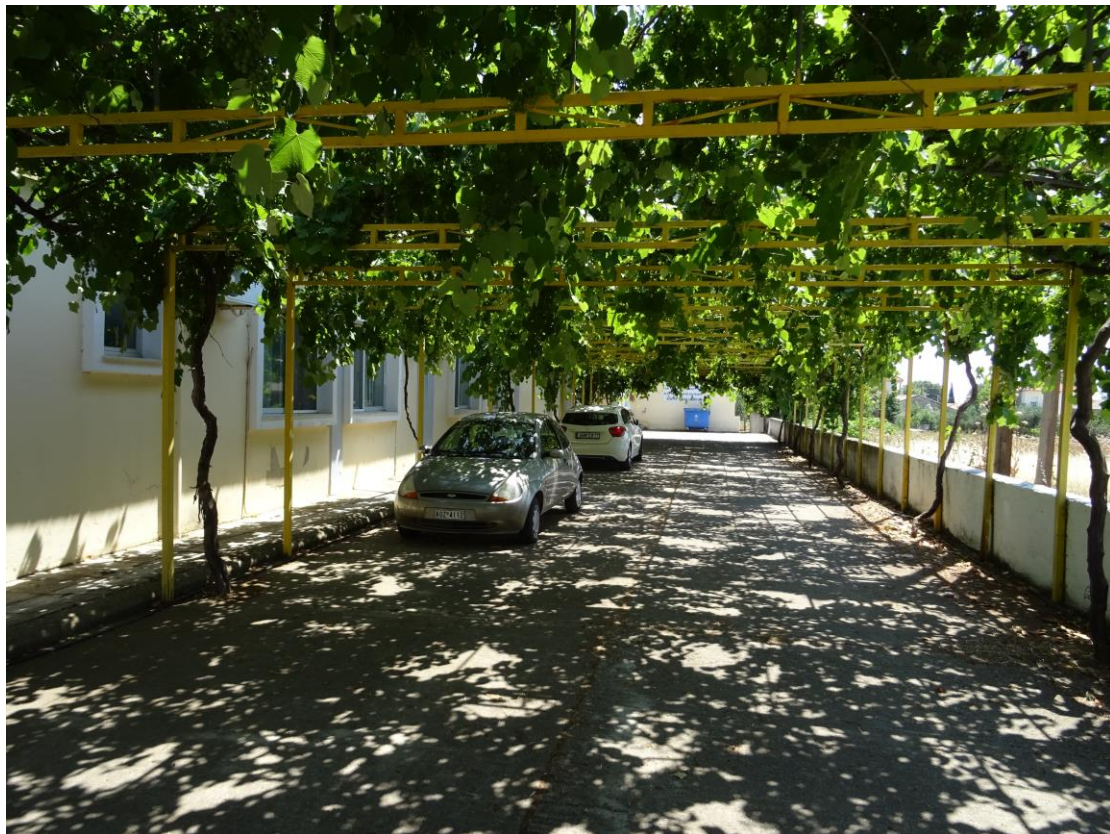
An additional parking space can be created near the building's third entrance, which is located at the eastern part of the building, and serves as a direct entrance to the laboratories.

Figure 4: Parking space at the building' s secondary entrance

In general, accessible parking spaces parallel to the pavement should be avoided. However, since this is the only solution for creating an accessible space near this entrance, the space should be designed with length not less than 6.00m so that it is possible for a person to pass between two parked -one behind the other - cars.

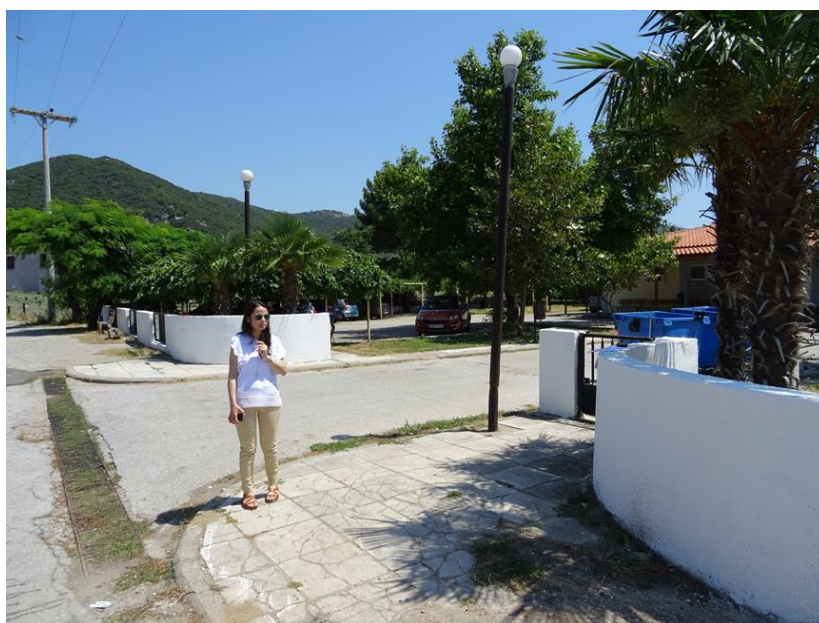
Access to the centre's yard is achieved through a main entrance which remains open. A smaller door is available for pedestrians, although due to the vast opening next to it remains unused.

Figure 6: Entrance to the centre's yard

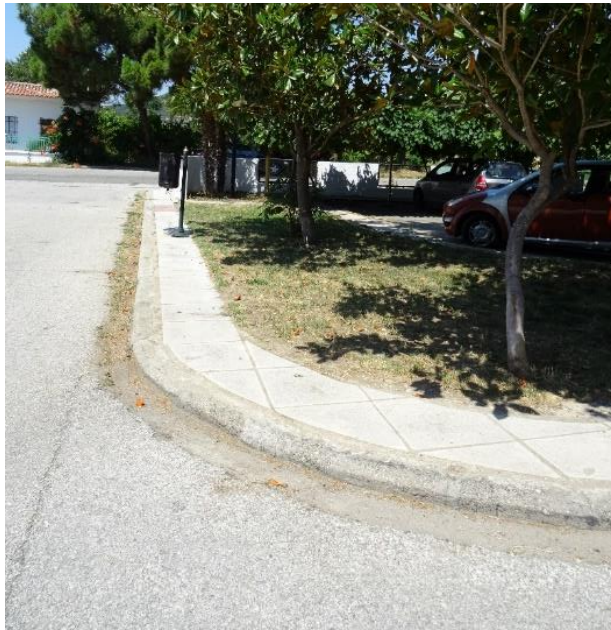
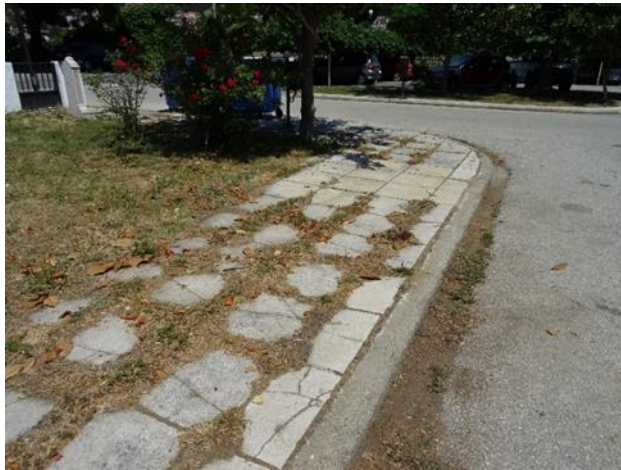
A pavement created by concrete tiles leads to the yard's entrance and continues to the inside. The pavement has sufficient width (varying from 2 up to 2,7m.), however it appears to have maintenance problems which create an uneven and not homogenous surface. Thus, resurfacing is considered essential for unobstructed use, focusing on maintaining the maximum available width of 2,7m..

Figure 7: The yard' s pedestrian pavement

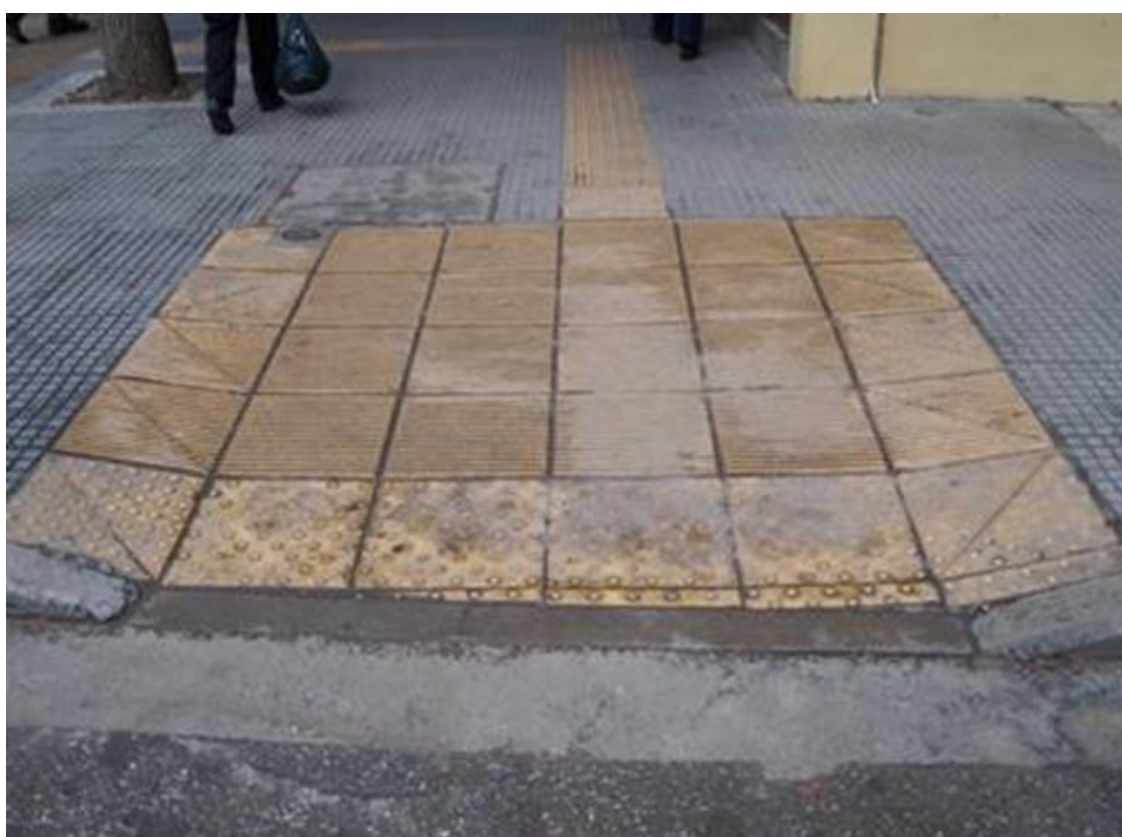
Thus, the current pavement height leads to a minimum required ramp length of 2,8 meters in order to achieve the desired 5% slope.

Figure 10: Indicative application of the accessibility guidelines

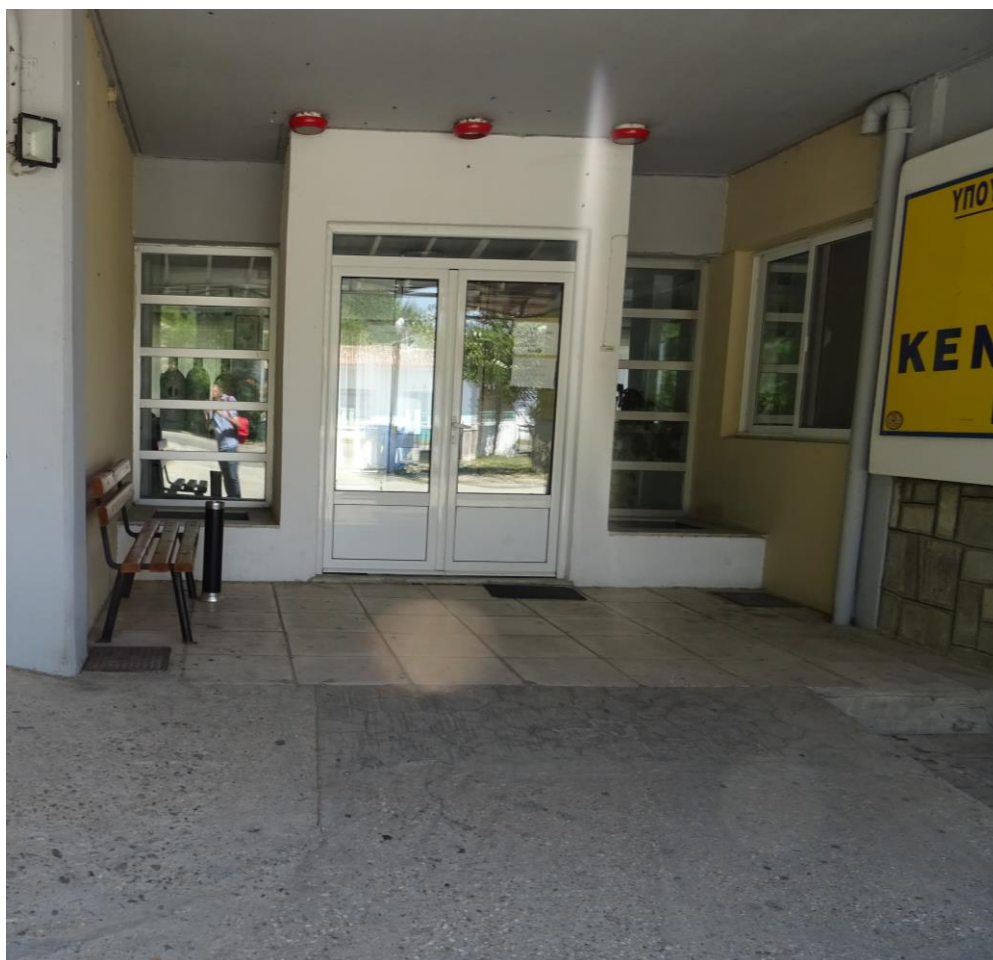
The main entrance has a small height difference with the adjacent pavement which is bridged through a concrete ramp. Its length is 3,9m., its width 2,25m. with an inclination of 6,9% with slight variations due to its construction. The maximum inclination indicated by the Greek accessibility guidelines is 5%, however the ramp created can be considered serviceable for wheelchair users. No handrails or tactile surface indicators are available. The concrete surface seems to offer sufficient slip resistance characteristics.

Figure 13: The building' s main entrance

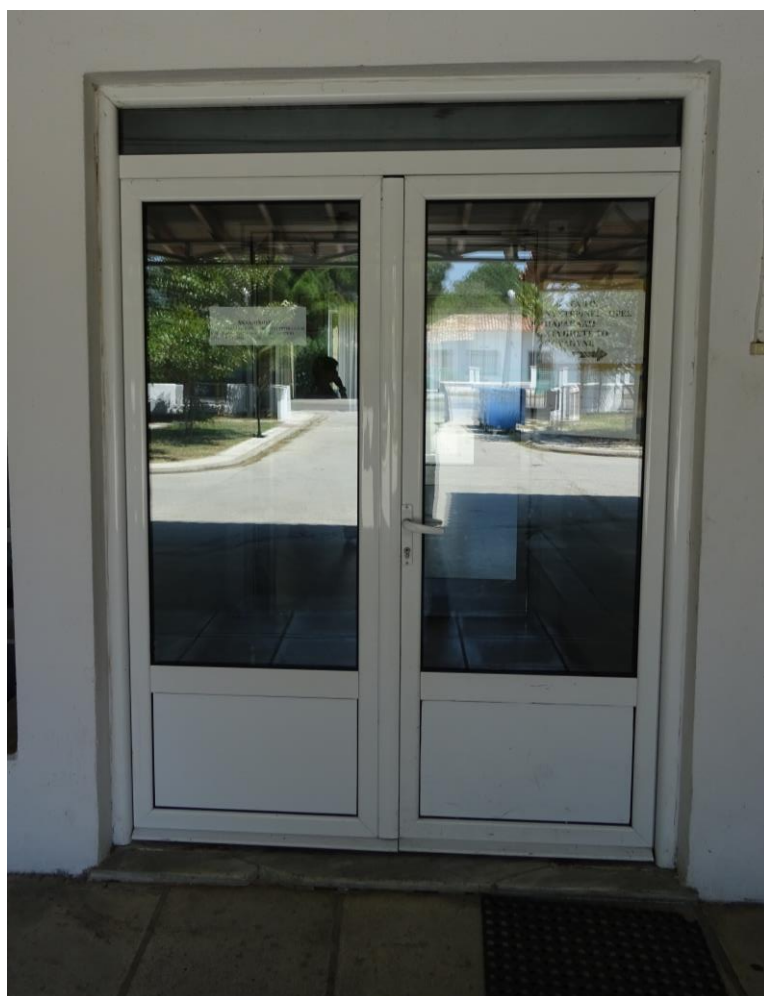
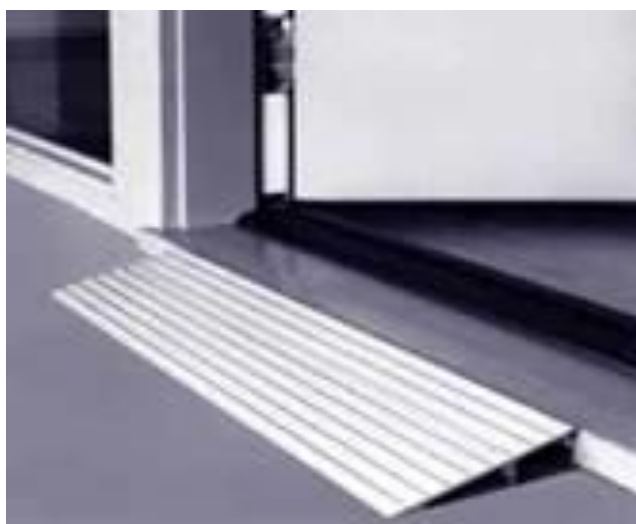
The main obstacle towards the main entrance is a 4cm. threshold that can be non-negotiable for wheelchair users, especially for users of motorized ones. Cheap and effective solutions for bridging this height difference could include the creation of a small concrete ramp or the installation of a small prefabricated metal ramp, similar to the one pictured below.

Figure 14: Main entrance and indicative threshold ramp

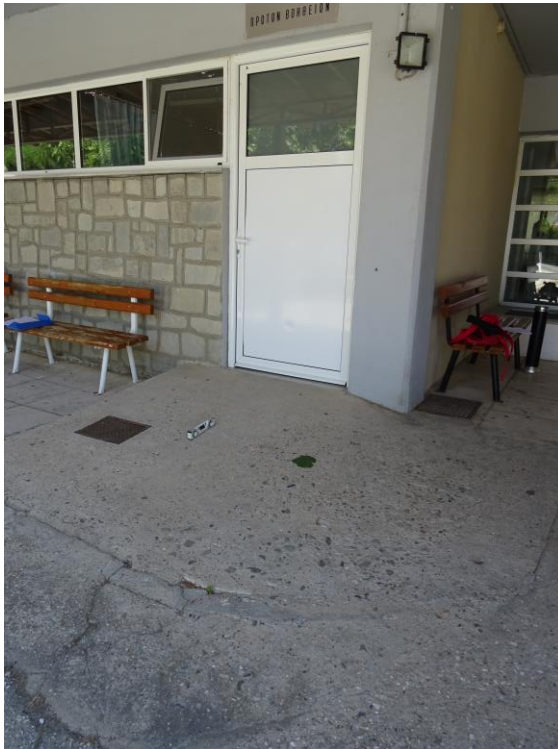
A concrete ramp leads to the entrance. The ramp's inclination is 12,4%, which is much higher than the maximum allowed by the Greek accessibility guidelines. The ramp is 2,9m. long and 2,0m. wide. The ramp leads to an opening door which is 1m. wide, opening to the inside of the building. A door handle is located 1m. high.

Figure 16: The second entrance leading to the emergency room

In this case the creation of an external ramp, parallel to the adjacent wall is proposed. The ramp's length is proposed to be at least 5m. with a suitable landing at the front of the emergency room's entrance

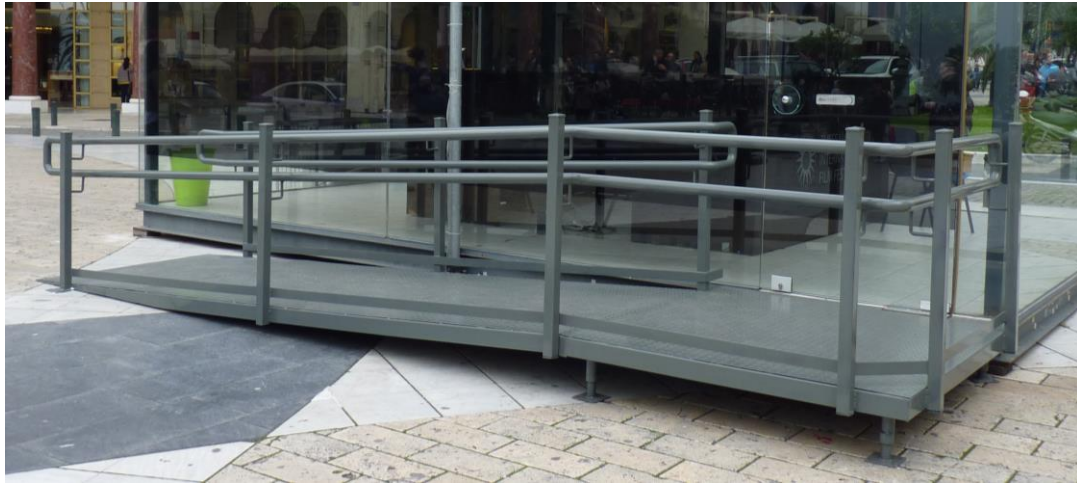
Figure 19: Photo of similar ramp design

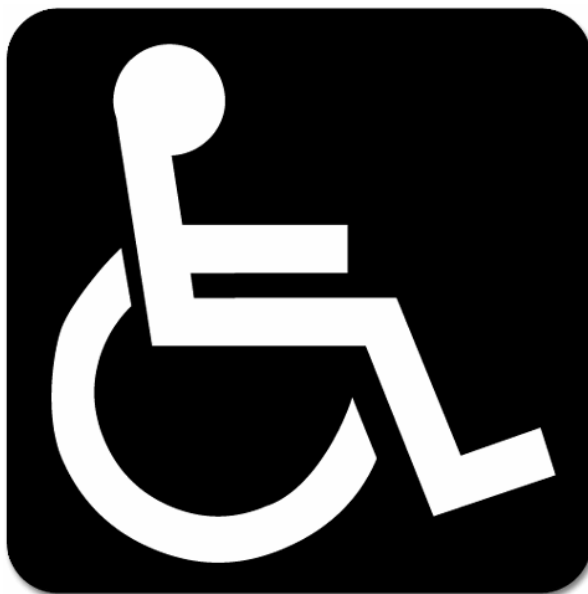
Figure 20: International Symbol of Access (white on black or blue)

If this solution is not followed, entering of wheelchair users should be made through the building's main entrance and through the internal door leading to the emergency room. The International symbol of Access should be installed at the main entrance to indicate the accessible route.

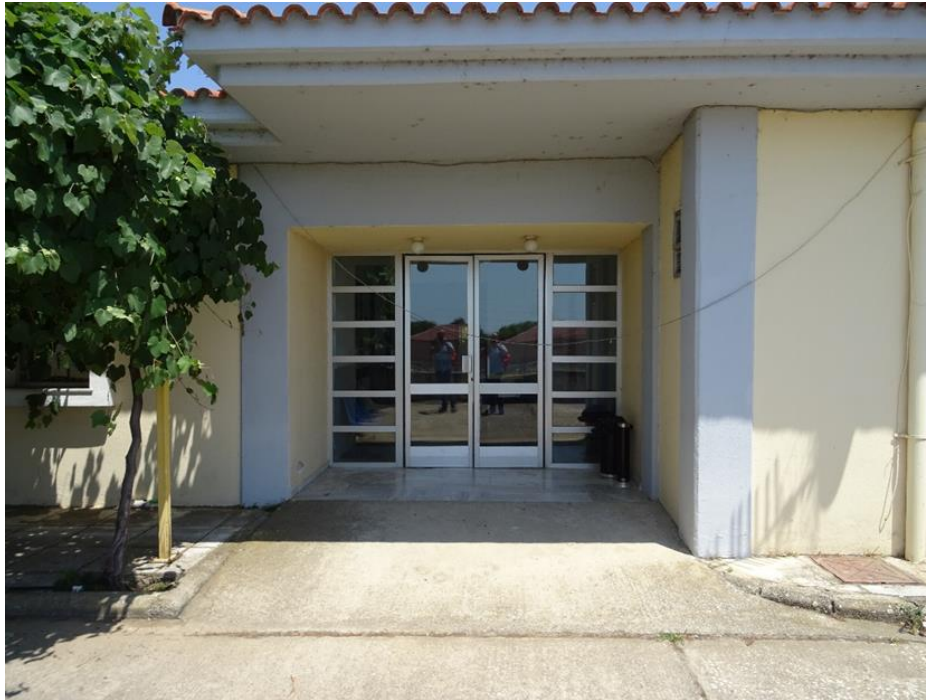
The third entrance, located at the eastern part of the building, serves as a direct entrance to the PHC laboratories. A ramp of 8,5% inclination, also made out of concrete, leads to it with a landing of sufficient dimensions with marble surface. Its length is 2,2m and its width is 3,15m. It should be noted that a cable, located at 1,45m. high, could be dangerous for visitors with restricted vision. Obviously, this should be immediately removed.

sufficient, particularly for users of motorized ones. The door is operated manually through a door handle located at 1,05m.

Figure 21: The building' s third entrance

The installation of suitable handrails could assist visitors with restricted mobility in negotiating this particular ramp. The proposed type is depicted in the following drawing:

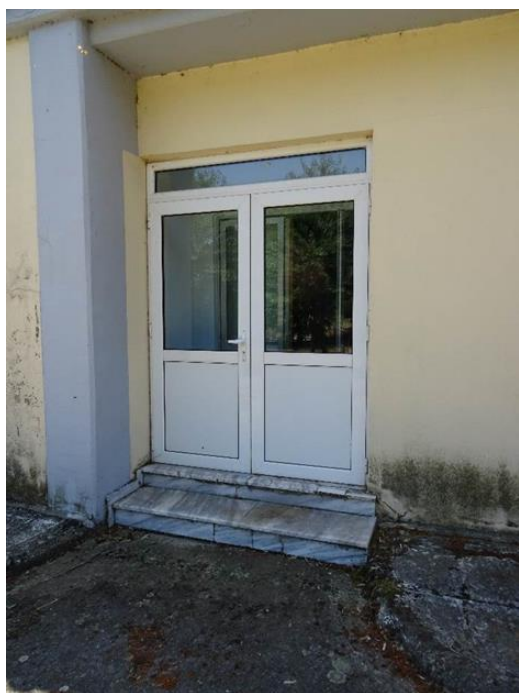
Figure 24: The centre' s secondary entrance

Since this is a secondary entrance to the building, only the installation of suitable handrails, as those depicted in figure 21 is proposed.

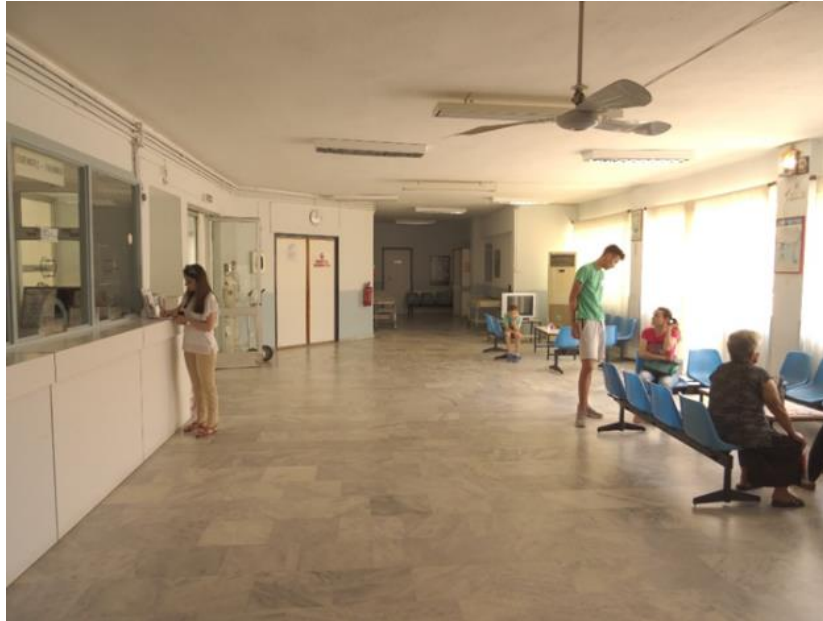
The main entrance leads to the centre's patients' waiting room, where also the centre's information desk is located. The room has considerable dimensions that make its negotiation easy, even for wheelchair users. The use of marble for the floor creates reflections for visitors with restricted vision and could create a slippery surface for visitors with mobility impairments.

Figure 26: The centre's waiting room and seats located at the centre's corridors

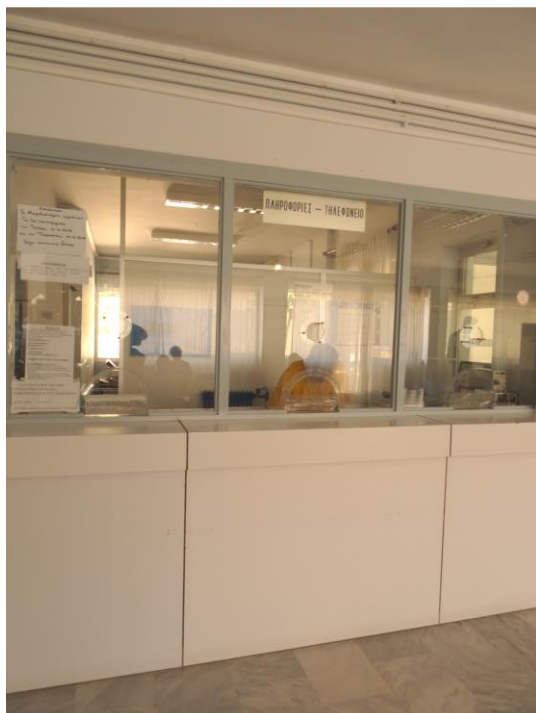
The information desk itself is located at 1,1m. high, not allowing wheelchair users to have unobstructed eye contact with the centre's employee. The desk has a useful surface which can be used by the visitor in order to fill in forms etc. The light grey colour against a white background does not create sufficient colour contrast.

Figure 28: Info desk at the hospital' s waiting room

According to the Greek accessibility guidelines, where reception or transaction counters are provided, a part of them at least 1.00 meters in length must be made at a height 0.80m from the floor. A solution similar to the one in the following pictures is proposed.

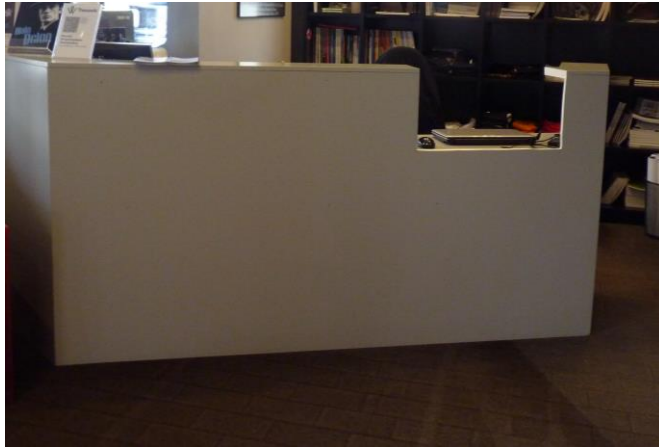
Figure 29: Proposed solution for the info desk

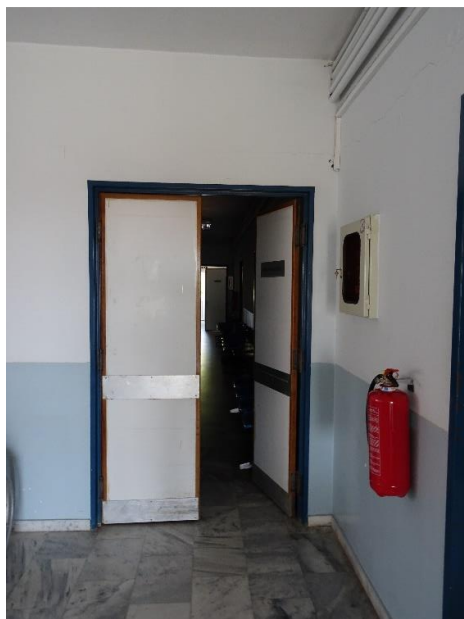
Figure 30: Internal door leading to corridors. Opening to both directions, 1,3m. clear width

In case of glass panels, signs, at a height of 1.40-1.60 m from the floor and in bright colours, should be placed to help people with vision problems.

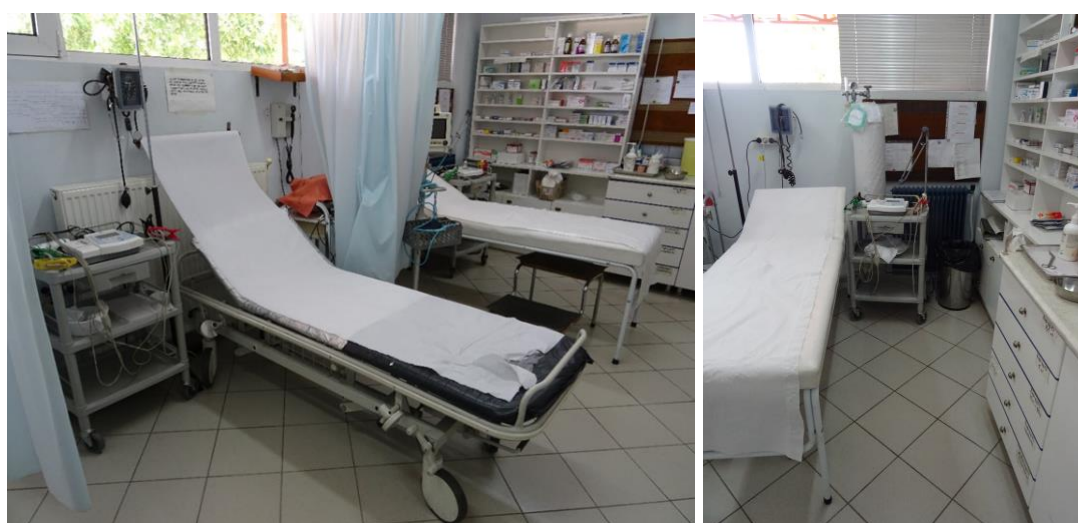
3 examination tables are located at the room with, the minimum available space around the tables being 70cm, which is not sufficient for the approach of wheelchair users. 2 of them have fixed heights from the floor (70 and 66cm.), with one having adjustable height. Between the two examination tables there is clear space 1m wide available, with the space towards the shelves located at the room being reduced to 70cm.

Figure 32: Examination room

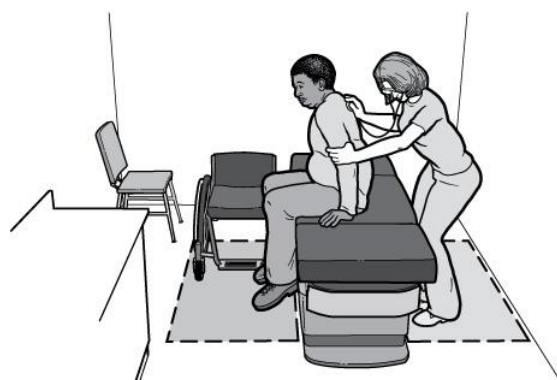
Because some individuals can only transfer from the right or left side, providing clear floor space on both sides of the table allows one accessible table to serve both right and left side transfers. Another way to allow transfers to either side of exam tables, particularly when more than one accessible examination room is available, is to provide a reverse furniture layout in another accessible examination room.

Figure 34: Patient transfer at examination table

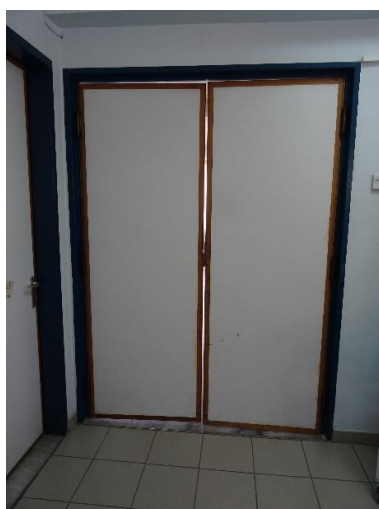
An internal door leads to the Centre's waiting room. It's an opening, 2 leaf door, with its free width being 1,40m. No door handles are installed. This is the door that can allow access to the emergency room to wheelchair users, in case they do not want to negotiate the external ramp.

Figure 36: Internal door leading the centre' s waiting room

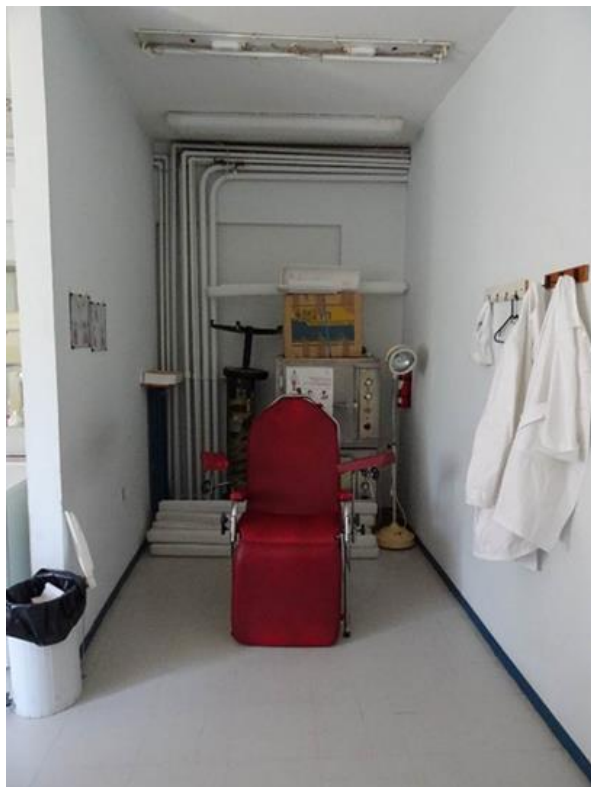
The abovementioned recommendations can be implemented in all the PHC centre's examination room. In particular, the room where blood sampling takes place is one of the most frequently used. The chair has arms that cannot be removed which may cause difficulties in the transition of a wheelchair user. The seat is located 62cm high, with the free width to either side being 65cm, again restricting the transition of a wheelchair user. Thus, the acquisition of a new chair is considered necessary.

Figure 39: Blood sampling room

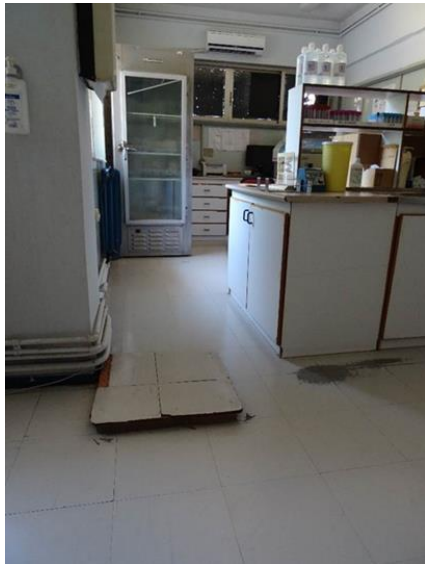
There is a protrusion of 6cm at the room's floor where, according to the centre's employees, an opening that serves an underground fresh water container is located. This does not allow circulation of wheelchair users at the rear of the room. Removing this is considered essential in order to allow access to wheelchair users.

Figure 40: Blood sampling chair and protrusion at the room's floor

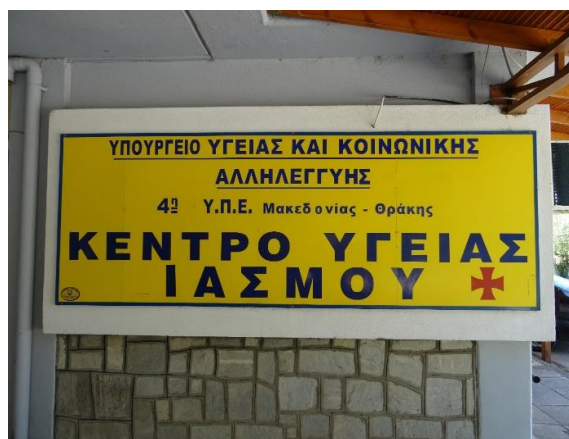
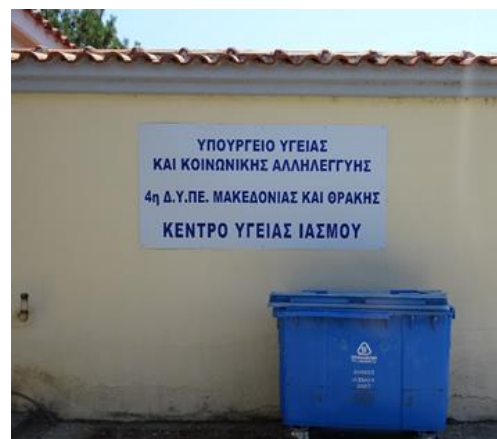
The building does not seem to have a signing study and does not have a standardized template for its signs. In many cases, the signs are created by the personnel in order to provide visitors with useful information. No tactile signage is available and no colour coding is used in any form.

Figure 41: Signs at the building's exterior

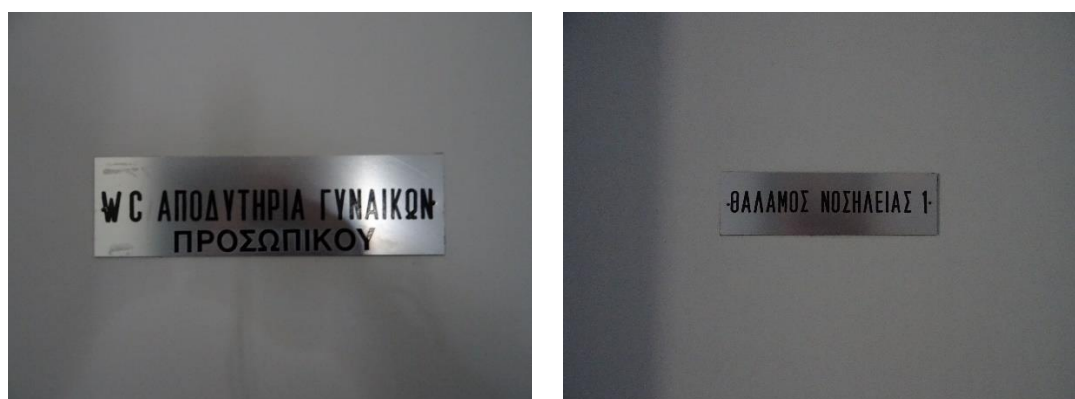
Figure 43: Signs at the building' s interior. Reflections makes them difficult to read

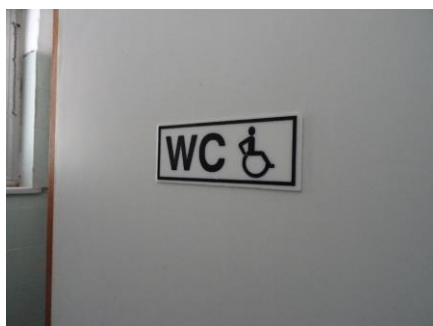
Figure 47: The door of the designated accessible toilet bearing the international symbol of access.

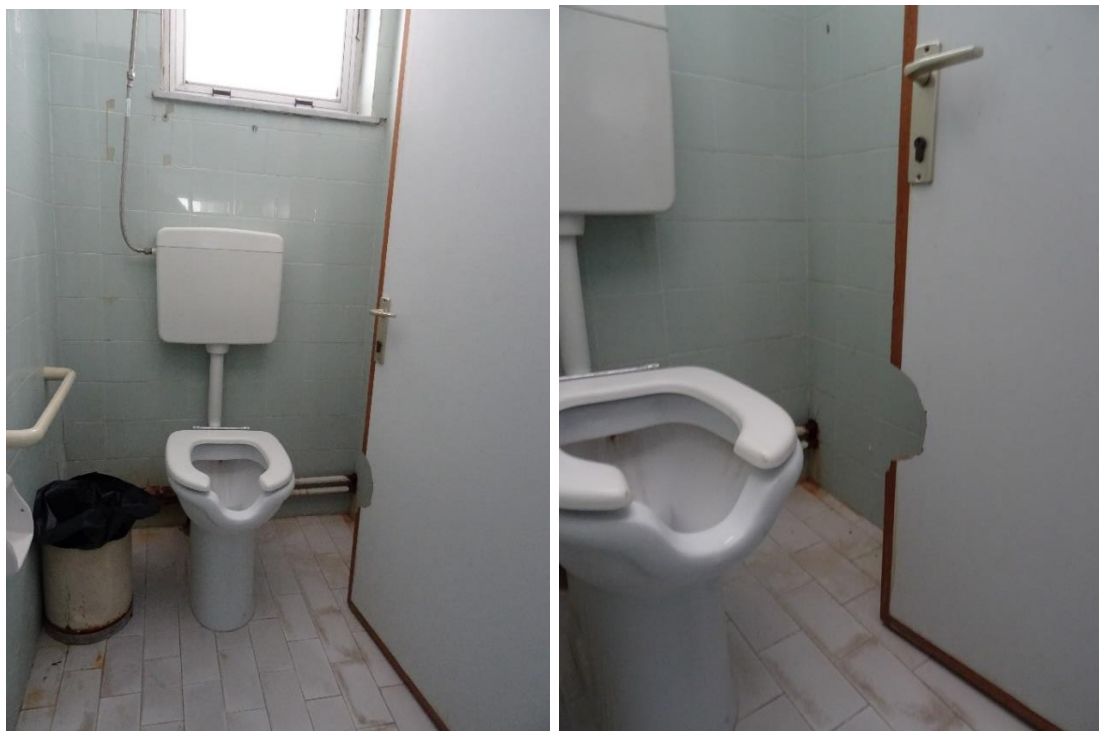
Figure 48: The designated accessible toilet

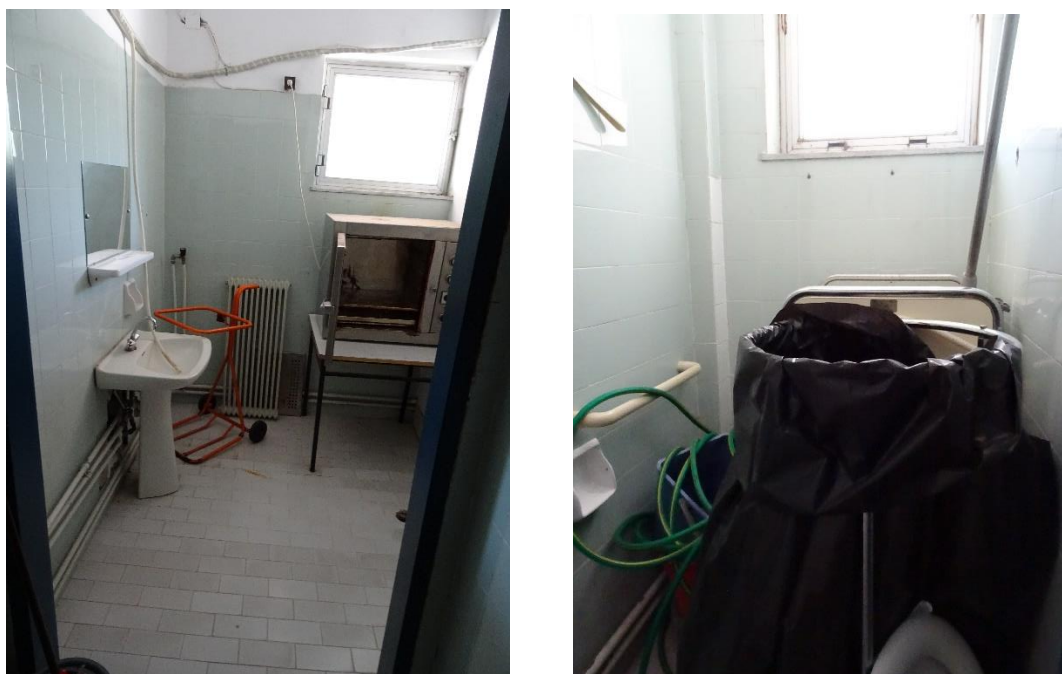
Figure 49: Rooms adjacent to the accessible toilet that can be used to increase its dimensions in case of a renovation

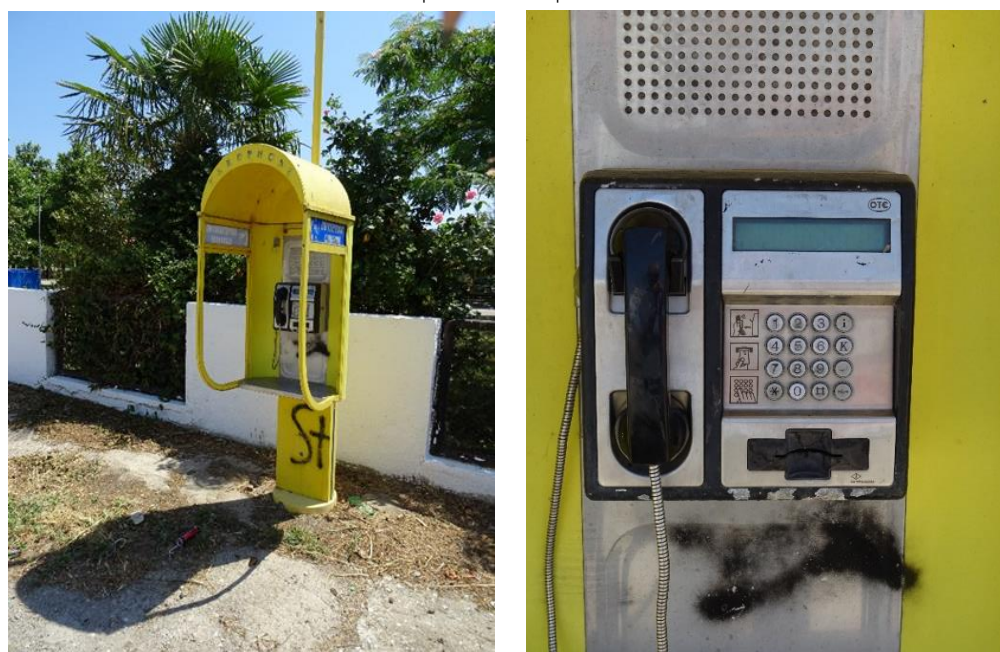
Figure 54: Public phone outside the centre's yard
